Crude Oil Tank Pressure-Vacuum Vent Damage

Bill Mott (Taku Engineering)

Prince William Sound Regional Citizens' Advisory Council

January 2025

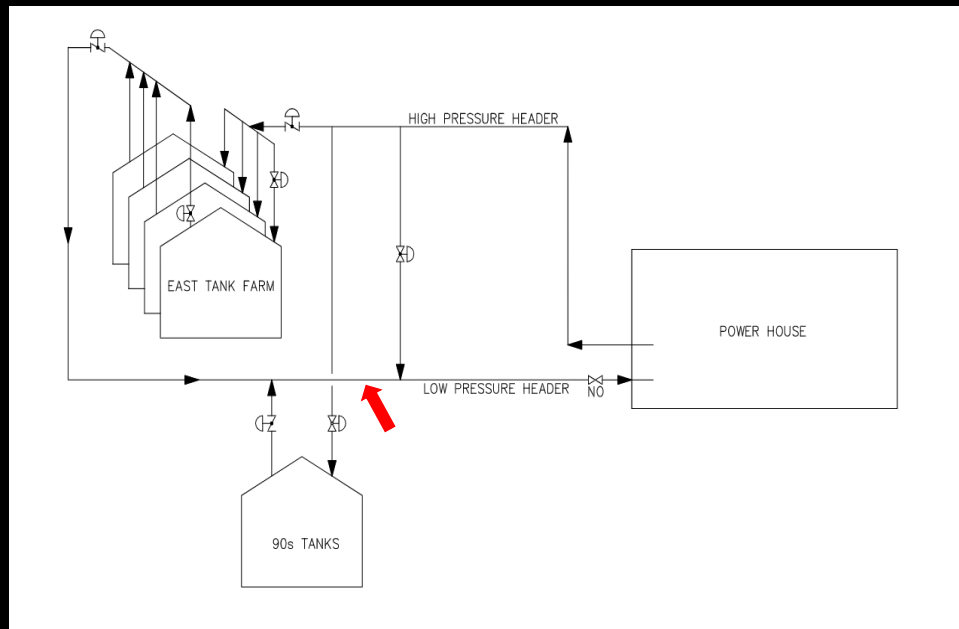
- 12 pressure/vacuum pallets had been sheared off tanks (significantly damaged pallets).
- The crude tanks are normally operated at a slight positive pressure. The mode was shifted to a slight vacuum (negative pressure) once vapor leaks were discovered in a tank.
- The O₂ Concentration in the Low-Pressure Header peaked at 5.59% on March 17th 2022.

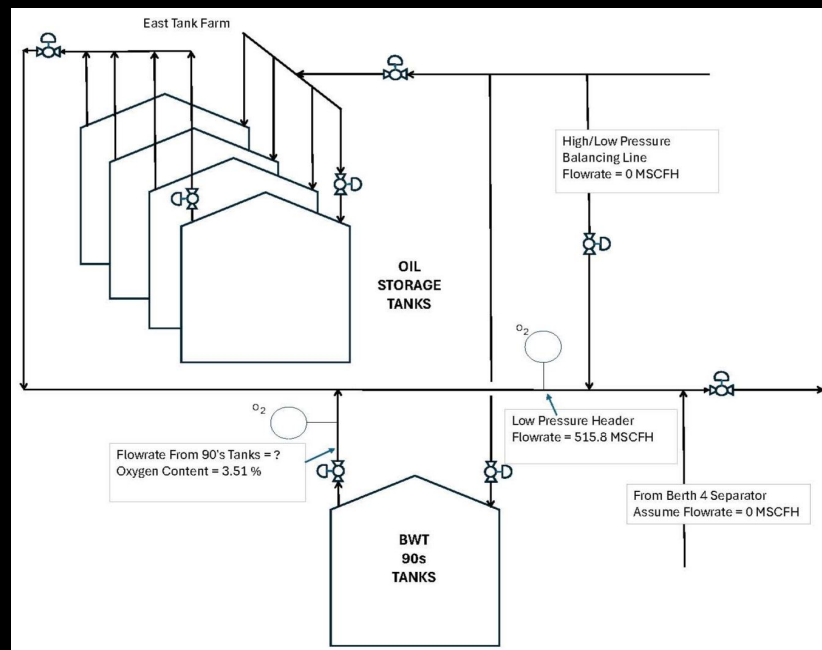
- The O₂ Concentration in the Low-Pressure Header peaked at 5.59 % on March 17th. While APSC noted that this was well below the alarm/actionable limit of 8% and therefore did not initiate any immediate action. Any measurable increase in the O₂ content of the Low-Pressure Header should initiate actions to ensure that each tank head space is not operating in the flammable range.
- The Low-Pressure Header normally contains blended gasses from 14 crude tanks and 2 ballast water tanks. A slight increase in the O₂ content of the Low-Pressure Header could be indicative of a significant increase in O₂ in one or more of the ETF storage tanks.

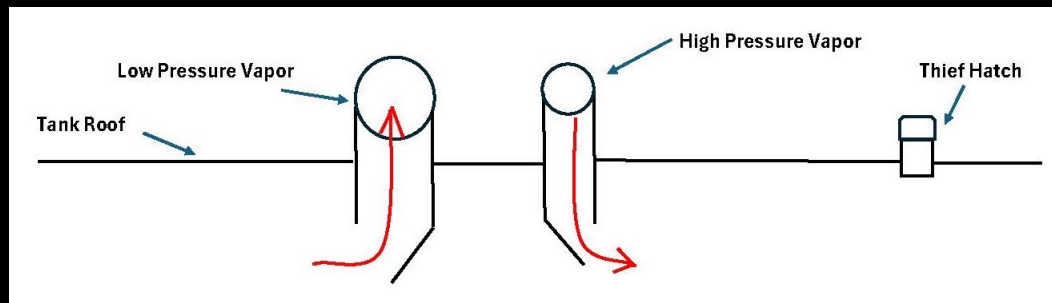
- Tank mixing is limited to flow diverters on the vapor nozzles
- The tank headspace is not homogeneous. Use of a single point to monitor the tank headspace would not provide accurate information to make decisions needed to adequately protect tank-top workers or accurately inform them about the risks associated with this work.
- On ½ of the tanks (odd-numbered tanks), the thief hatches are located in a position that renders them unable to accurately estimate overall headspace quality.

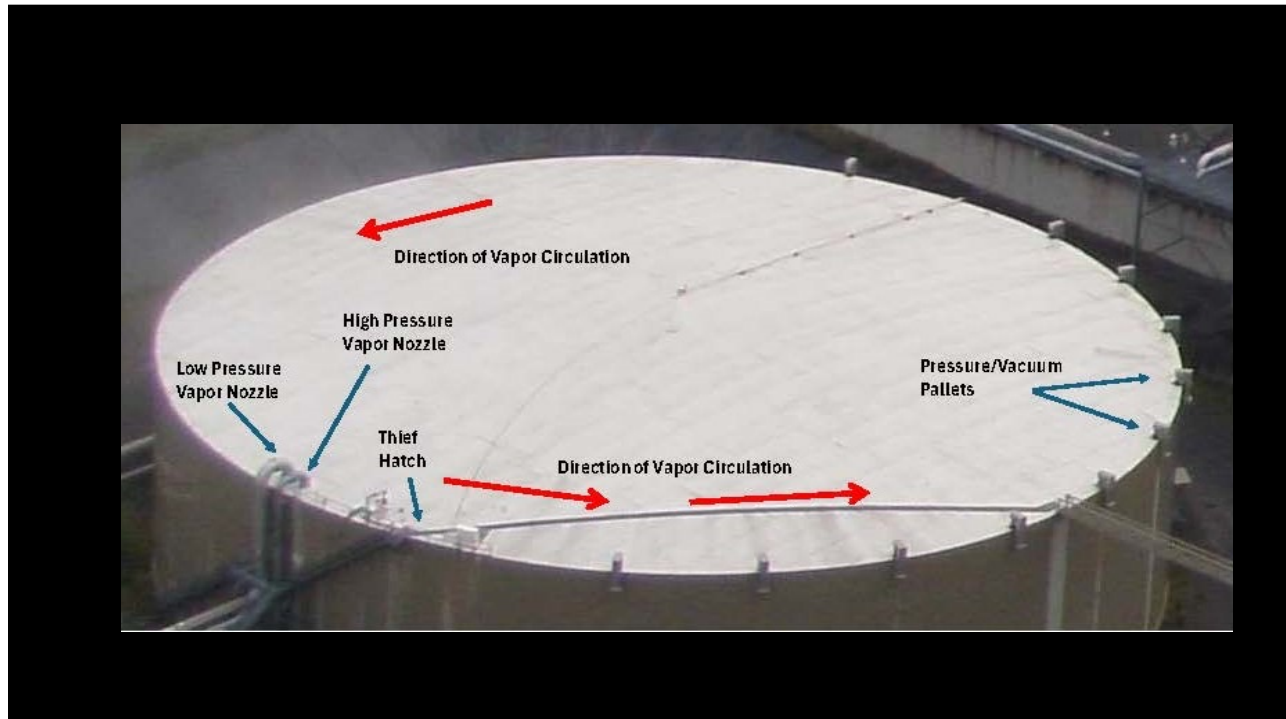
- The crude tanks are normally operated at a slight positive pressure. The mode was shifted to a slight vacuum (negative pressure) once vapor leaks were discovered in a tank.
- In my professional opinion, once the tank operating mode was shifted to a slight vacuum in the headspace, localized areas of the headspace near the significantly damaged pallets contained a flammable gas mixture.
