Briefing for PWSRCAC Board of Directors – January 2025

Report Acceptance: Calculations Used in Tank Vent Headspace Report 4-3

2022 Tank Pressure/Vacuum Pallet Damage: Crude Oil Storage Tank Headspace Gas Assessment

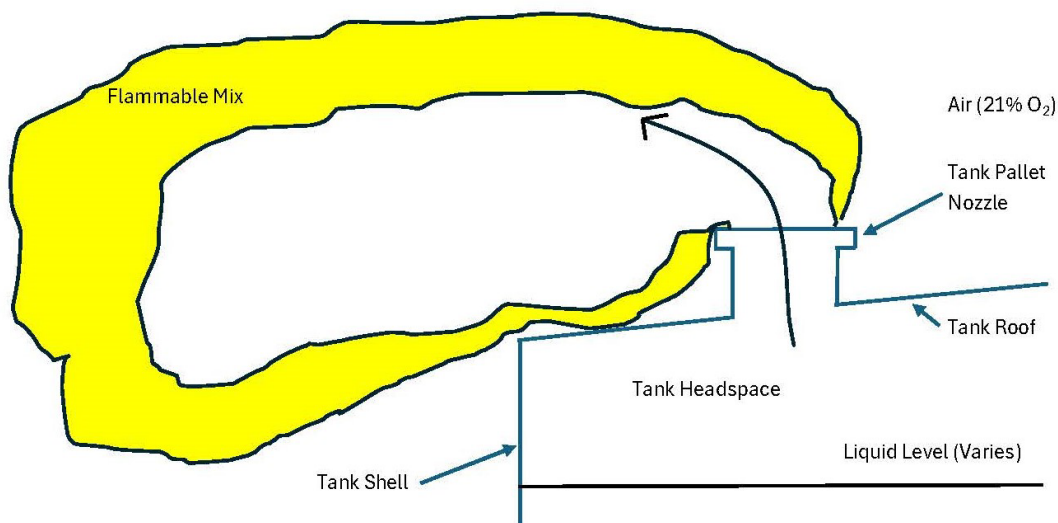
Alyeska indicated that the tanks are normally operated under a slight pressure. As depicted below, when a tank pallet is sheared off a tank operating at a slight pressure, the headspace is open to the atmosphere and hydrocarbon vapors migrate out of the tank resulting in fugitive emissions. These fugitive emissions are what Alyeska’s technicians detected in their “olfactory test.” When there is a leak and the tank is operating at a slight pressure, there will be a flammable region (depicted as yellow in Figure 1, below) in the emissions cloud. The size and magnitude of the flammable region will vary and be impacted by the leak rate, temperature, and outside wind speed.

Figure 1 - Tank Emissions at Sheared Pallet (Operating under positive pressure)

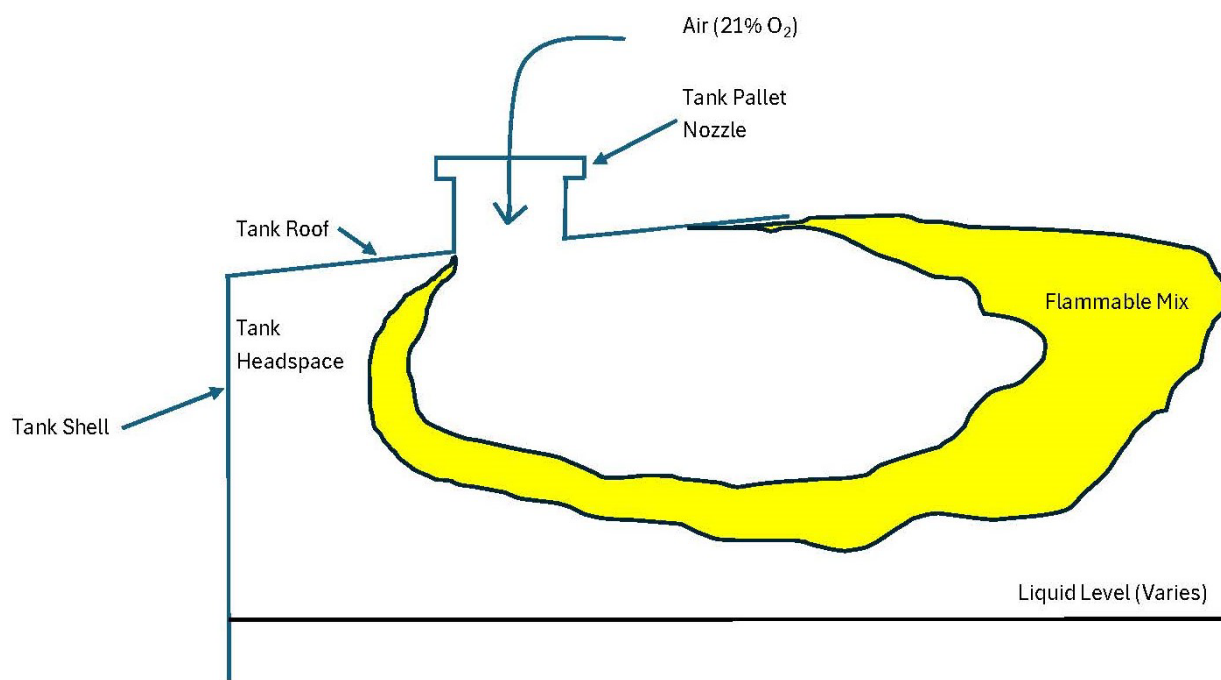
Alyeska noted that when leaking pallets were discovered on a subject tank, the operating mode for that tank was shifted to operate with the headspace under a slight negative pressure (vacuum) to limit the release of hydrocarbon vapors to the atmosphere. Whenever there is a significant tank leak and the tank headspace is

under a slight vacuum, the air migrating into the tank will create zones where the O₂ concentration is high enough for a flammable/explosive mixture to exist (depicted as yellow in Figure 2 below). Again, this is due to air moving into the tank and the fact that the current mechanisms for headspace gas mixing do not result in a homogeneous gaseous mixture. The size and magnitude of that flammable region will be impacted by the leak rate, temperature, the amount of mixing in the headspace, the volume and age of the oil in the tank, and the magnitude of the operating negative pressure (vacuum). A significant leak in a single tank will also increase the bulk average O₂ content of that tank headspace.

Figure 2 – Air Migration into a Sheared Pallet (Operating under negative pressure - vacuum)

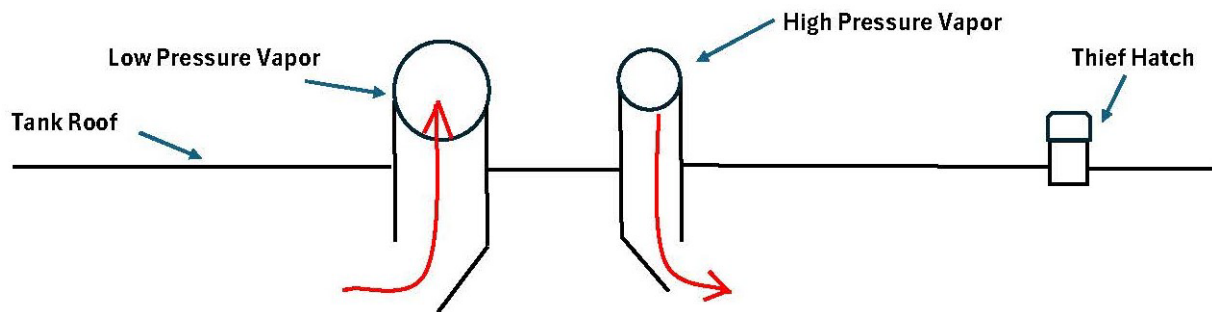
During the March 31, 2022 meeting, Alyeska reported that they used the tank thief hatches to sample headspace gases to determine if the tank headspaces were safe to put workers on top of the tanks for snow clearing. Reliance on testing at the thief hatches as the primary means of defining the headspace gas quality was imprudent as the thief hatches on the odd numbered tanks are located close to the high-pressure header between the high-pressure header and the closest pressure/vacuum pallets. That means that the

quality of the gases at the thief hatched on the odd numbered tanks will closely mirror the quality of the high-pressure header, not the bulk tank headspace.

Figure 3 – Vapor Nozzle/Thief Hatch Proximities for Odd Numbered Crude Tanks

Figure 3 presents a basic sketch showing the inert (high pressure or inert) nozzle, the vent (low pressure outlet) nozzle, and the thief hatch for the seven northern ETF tanks (odd # tanks). As seen from this visual representation, based on the tank vapor nozzle locations, the orientation of the vapor diverters (if installed on a given tank), and the relative location of the thief hatch, gas readings at the thief hatch will be similar to the quality of the high-pressure header gases entering the tank rather than representing the average or bulk quality of the tank headspace.

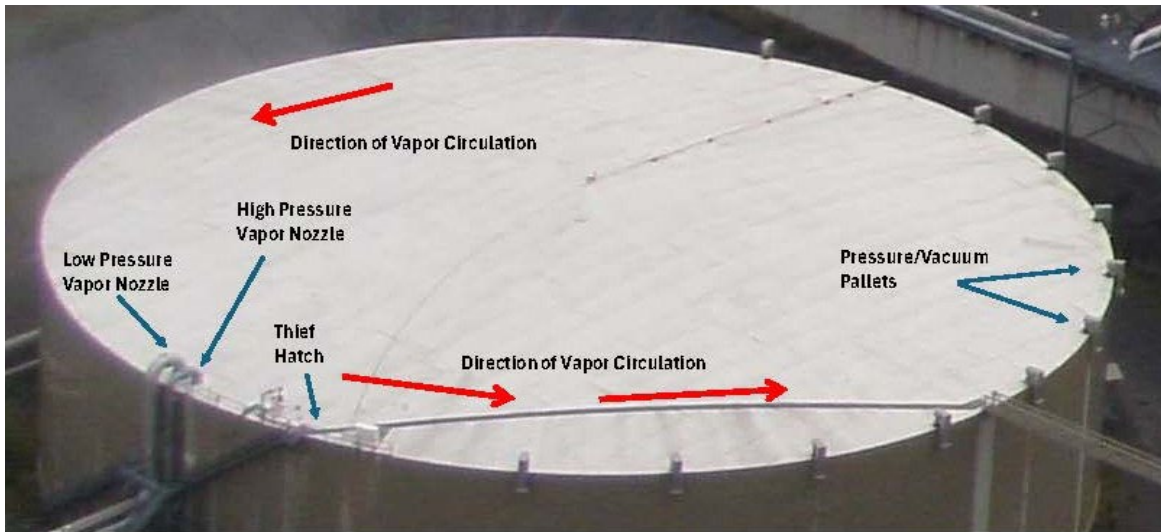
Figure 4 – Tank 11 Roof Appurtenances

Figure 4 shows the roof of Crude Oil Storage Tank 11, depicting the locations of the inlet and outlet nozzles, the thief hatch, the pressure vacuum pallets, and the vapor flow direction that would be expected if vapor diverters were installed (red arrows). In this configuration, as seen visually in the diagram, the headspace gases at the thief hatch will be similar to the quality of the high pressure (inert) gas than the bulk of average quality of the tank headspace. Gas testing collected at thief hatches on the northern tanks (odd # tanks) is very unlikely to include O₂ that enters the tank through damaged pressure vacuum pallets.

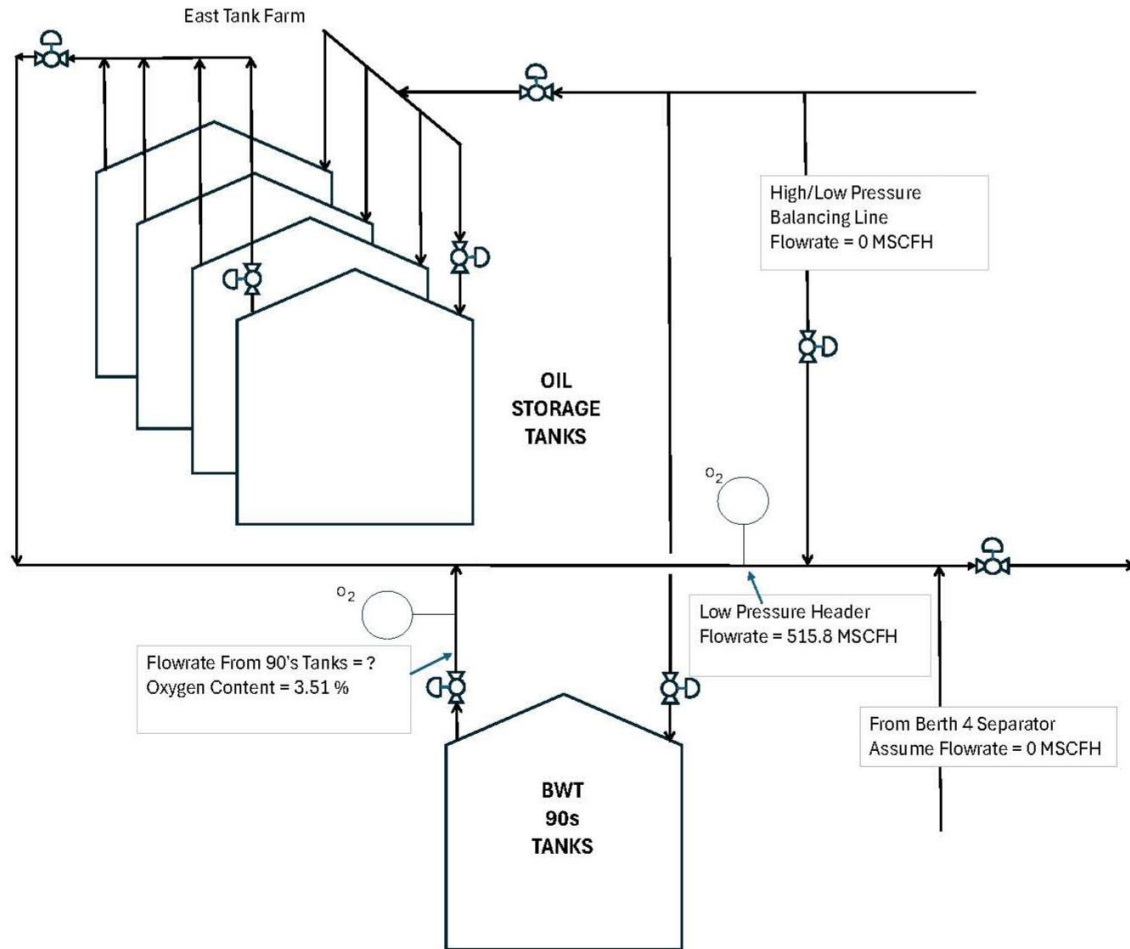
Figure 5 – LP Header Flow Diagram

The flowrate into the compressors (641.8 MSCFH) is the sum of the flow from the LP header and the flue gas scrubber flow (126.0 MSCFH).

$$\text{The LP Header flowrate from the ETF \& BWT} = 641.8 \text{ MSCFH} - 126.0 \text{ MSCFH} = 515.8 \text{ MSCFH}$$
