FINAL REPORT

Review of Ballast Water Tank 94 and Crude Oil Storage Tank 7 Out-of-Service Inspection Reports

May 2024

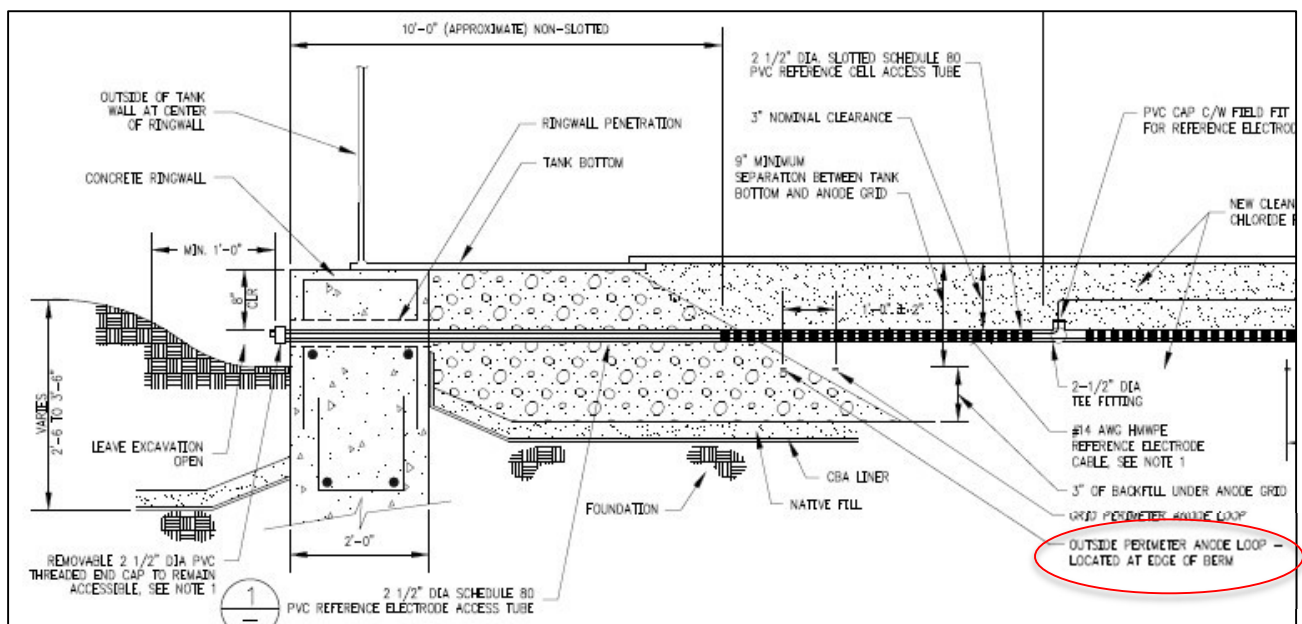
Figure 4 – Tank 7 Annular Ring CP Ground bed Design

This anode configuration does not protect the annular plates and perimeter floor plates for the following reasons.

The MMO loop that is dedicated for the annular plate and perimeter floorplates is tied to a single circuit that cannot be adjusted independently of the rest of the anode groundbed. Even if the system had the ability to independently power the MMO loop nearest to the annular plate, the resulting CP current will go predominantly to the perimeter floorplate and will not measurably impact the annular plate.

In response to the draft of this report, APSC indicated that contrary to the as-built drawings, the first 10 feet of the CP monitoring tube is slotted. This should have enabled APSC to collect CP data for the perimeter area. However, no area CP data was reported for the outermost 10 feet of the tank despite the reported presence of slotted tube. Given that the empirical data indicates elevated corrosion rates in this area, the collection of area CP data should be prioritized. Further, the conflict between the system drawings and their reported condition raises the concern that APSC has not maintained accurate as-built drawings of their systems.

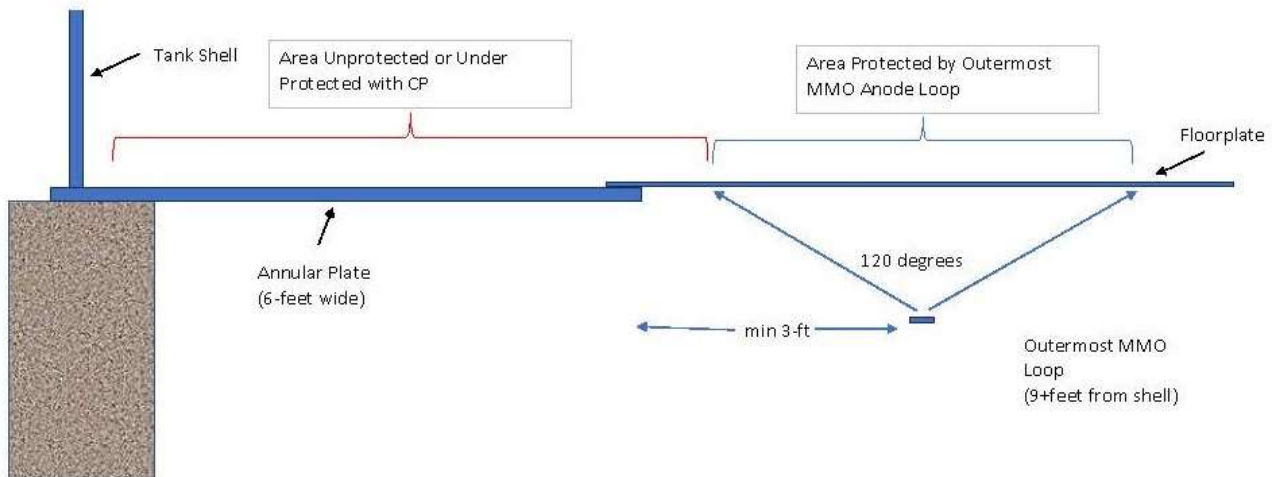
Figure 5 – Tank 7 CP System Perimeter Current Distribution

During the 2021 tank outage, 15 patch plates were installed due to bottom-side corrosion. Nearly all repairs were on perimeter floorplates, validating that the CP current being provided to the perimeter areas is insufficient and that water intrusion through the failed annular plate extension to ringwall seal is causing corrosion.

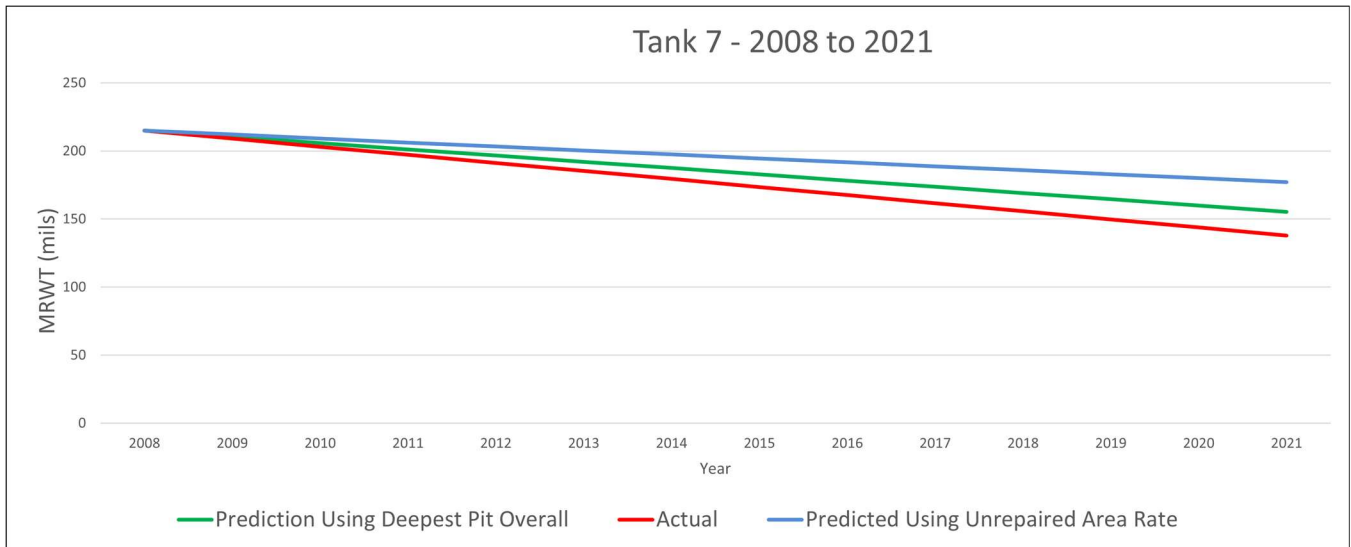
Figure 6 – Corrosion Rates for the Tank 7 Floorplates 2008-2021

Figure 6 graphically presents the predicted 2008-2021 corrosion rates on the Tank 7 floorplate compared to the actual rates as discovered during inspection. The blue line represents the predicted floorplate corrosion rates based on the deepest unrepaired pit from 2008 (as allowed by API 653). That predicts that the 2008-2021 corrosion rate would have been 2.92 MPY with a minimum remaining floor thickness (MRFT) of 177 mils.

The green line in Figure 6 represents the predicted 2008-2021 corrosion rate based on the overall deepest pit discovered during the 2008 inspection.⁵ That predicted a soil-side corrosion rate of 4.58 MPY and a MRFT of 155 mils.

The red line in Figure 6 represents the actual 2008-2021 Tank 7 soil-side floorplate corrosion rate of 5.92 MPY and a MRFT of 138 mils.

The 2008-2021 Tank 7 floorplate corrosion rate predicted using the deepest unrepaired pit discovered in 2008, underestimated the actual corrosion pitting depth by 51%.

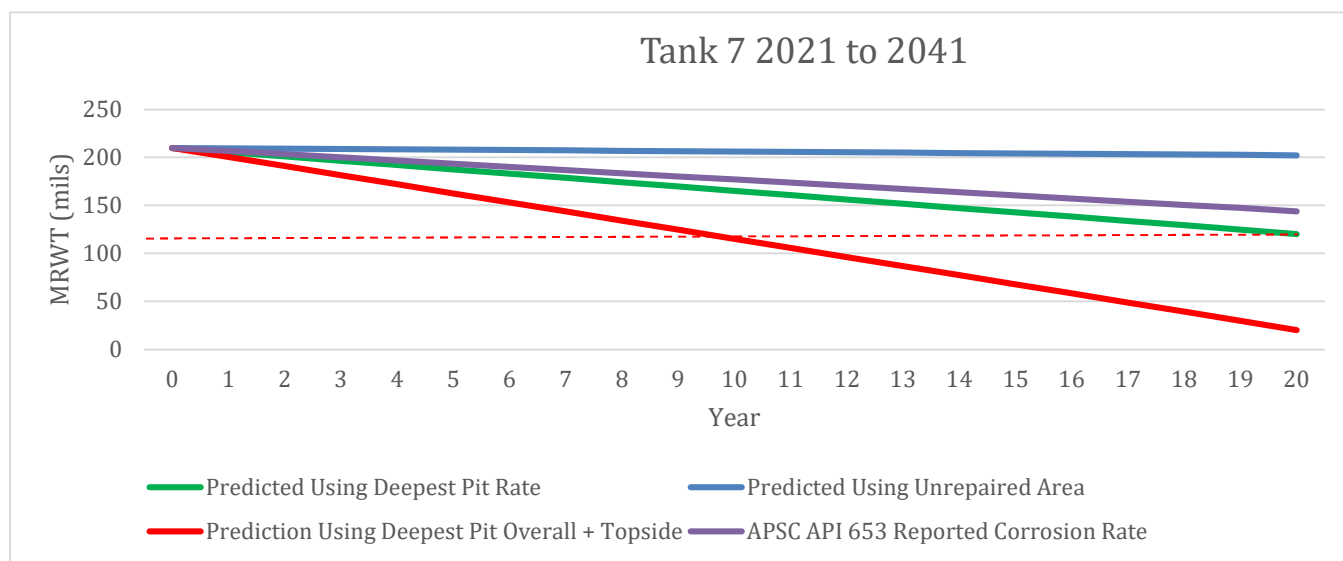
Figure 7 – Predicted Corrosion Rates for Tank 7 (2021-2041)

Figure 7 provides a graphical representation of the predicted floorplate corrosion rates for Tank 7 for the 20-year service interval that the APSC API 653 report recommends.

The blue line in Figure 7 represents the predicted Tank 7 2021-2041 floorplate corrosion rate based on the unrepaired areas from the 2021 inspection. Although allowed by API 653, empirical data for Tank 7 suggests that this significantly underestimates the actual corrosion rate.

The purple line in Figure 7 represents the predicted Tank 7 2021-2041 floorplate corrosion rate as reported in the APSC 2021 API 653 report. That rate does not appear to align with API 653 procedures.

The green line represents the predicted Tank 7 2021-2041 floorplate soil-side corrosion rate based on the deepest floorplate soil-side pit identified in the 2021 inspection. However, this does not include a topside corrosion rate, which is prudent given the age of the existing coatings.

The red line represents the predicted Tank 7 2021-2041 floorplate soil-side corrosion rate based on the deepest floorplate soil-side pit identified in the 2021 inspection, along with a 5 MPY topside corrosion component.

This approach, based on empirical data for Tank 7, predicts that if the tank is returned to service for 20 years, as the APSC API 653 report suggests, the floorplate thickness will fall below 100 mils between 2031 and 2032. Most critically, it also predicts that the floor will leak between 2040 and 2041, if action is not taken to correct current corrosion rates.

The Tank 7 Engineering Summary Report includes calculations based on a long-term bottom-side floorplate corrosion rate of 4.48 MPY and a topside floorplate corrosion rate of 4.42 MPY. The Engineering Summary Report recommended that the tank be removed from service for inspection again in 12 years or 2034. Taku’s calculations predict that the tank minimum floorplate thickness will fall below 100 mils between 2031 and 2032.

Calculations for the next tank service interval should use a bottom-side corrosion rate of 5.92 as this meets or exceeds API 653 requirements and aligns with empirical data on APSC’s tanks.

The service interval calculations should include a topside corrosion rate of at least 5 MPY.

Based on a 2021 MFE inspection and repair threshold of 210 mils, a short-term soil-side corrosion rate of 5.92 MPY and a topside corrosion rate of 5 MPY, the tank should be removed from service again for inspection 10 years after the last inspection (or 2031).

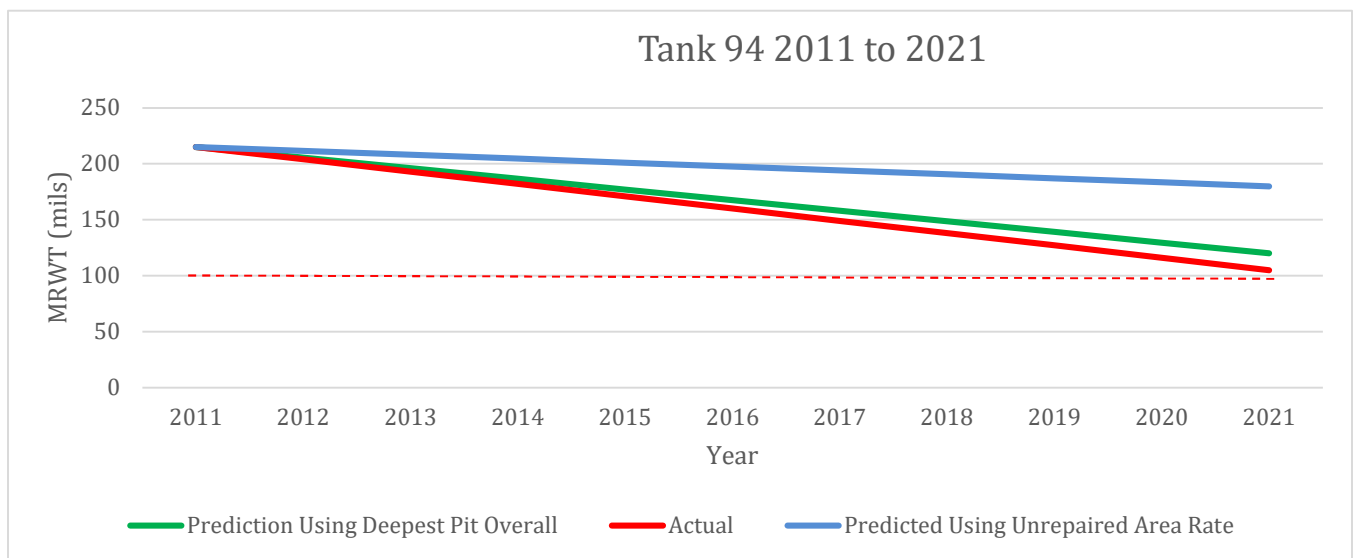
Figure 8 – Predicted Versus Actual Corrosion Depths for Tank 94

Using the 2011 deepest pit to define the 2011-2021 corrosion rate, the actual rate of corrosion was underestimated by 14%. Using the deepest unrepaired pit (from the 2011 inspection) to predict the Tank 94 floorplate corrosion rate between 2011 and 2021, the actual corrosion rate was underestimated by 68%.

This finding is not unique to Tank 94. Across nearly every APSC tank that we have data on, the use of the corrosion rate in the unrepaired area as the basis for predicting future corrosion on the tank floors significantly underestimates the corrosion that occurs during ensuing service intervals (see data for additional tanks in Attachment A). **With that data in hand, it would be remiss for APSC to continue the practice of using corrosion rates from unrepaired areas, to predict corrosion rates in ensuing service intervals.**

Given that the tank is experiencing active corrosion, the operator should not assume that the CP system is effective. As such, APSC should plan to remove the tank from service for the next inspection before the MRFT drops below 100 mils.

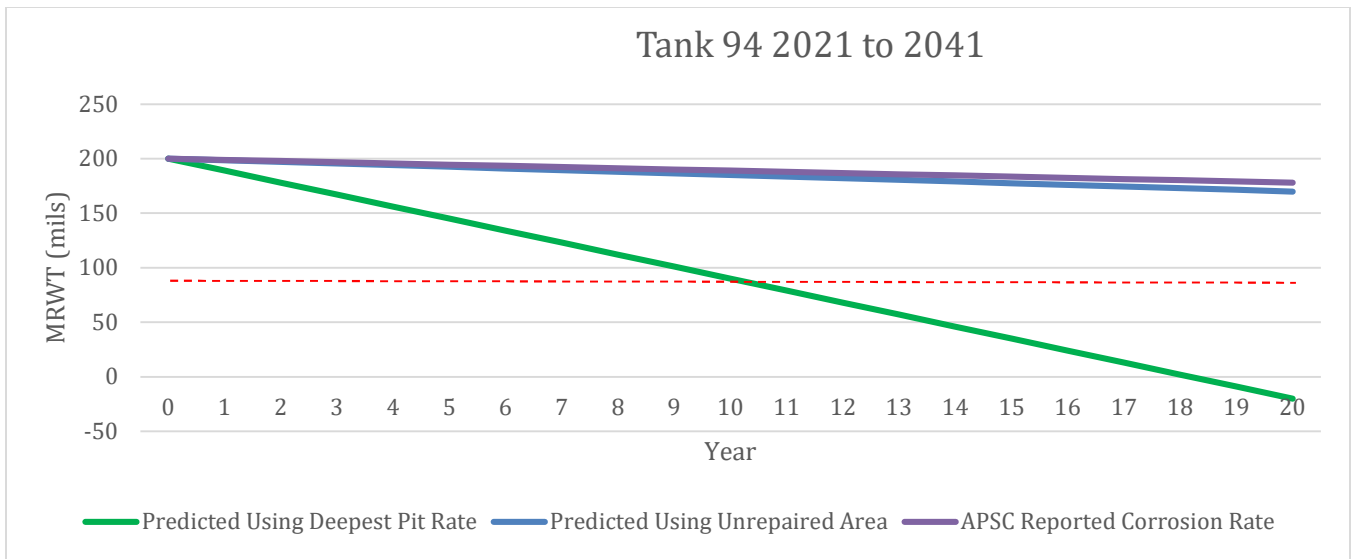
Figure 9 – Predicted Corrosion Rates for the Tank 94 Floorplate Between 2021 and 2041

Further, the floorplate corrosion rates reported between 2011 and 2021 indicate that the CP system is inadequate to protect the perimeter floorplate (and annular plate) from corrosion. No upgrades to the CP system were executed during the 2021 repairs.

The addition of a drip ring on Tank 94 is a great step in helping alleviate corrosion. However, many of the causes of corrosion are still in place and have not been remediated. The CP current density in the perimeter is insufficient and the soils beneath the floorplates are likely contaminated with chlorides. The sub-floorplate soils were not replaced and the CP system was not upgraded. **Based on empirical data for Tank 94, the next out-of-service inspection on Tank 94 should be executed in 2030, not 2041 as proposed in the API 653 report or 2031 as proposed in the Engineering Summary Report.**
