**Briefing for PWSRCAC Board of Directors – May 2025**

**Project number and name or topic:** 6512 – Maintaining the Secondary Containment Liner

**Review of Electrical Leak Location and Electrical Resistivity  
Tomography Pilot Study of the Secondary Containment System at  
the Valdez Marine Terminal West Tank Farm Conducted July 2024**

22 January 2025

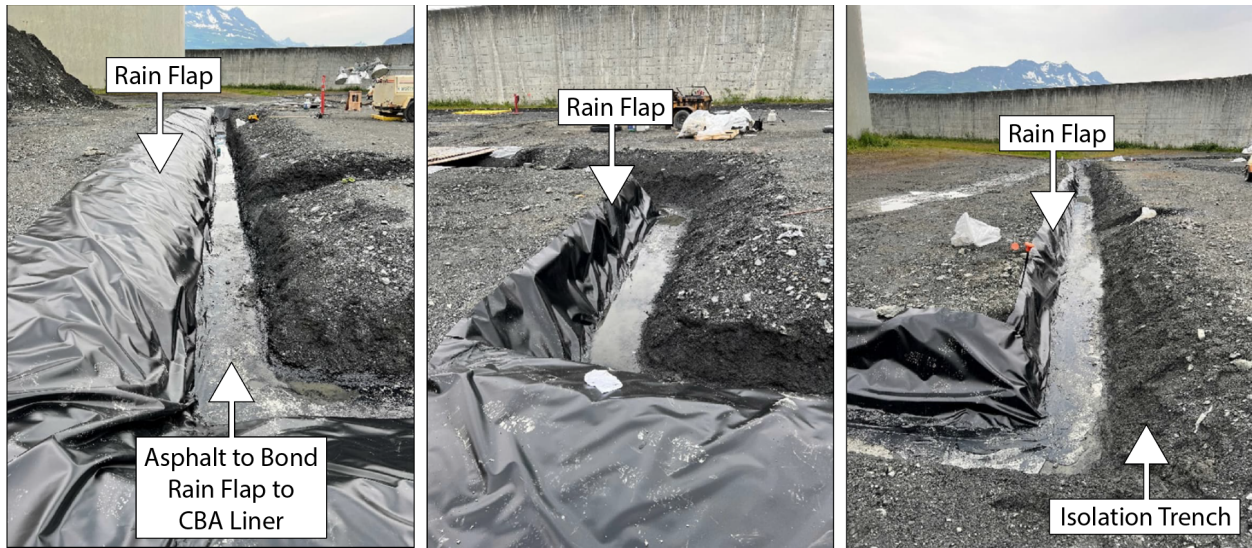
**Figure 3. Photographs of installed rain flap (from WSP 2024a).**

The effectiveness of ELL and ERT depends on electrical isolation of the test area (open air and the CBA barrier layer serve as electrical insulators). Achieving electrical isolation was the most difficult aspect of the pilot study fieldwork. Prior to testing and isolation, a trench (moat) was excavated around the perimeter of the test area to the CBA (refer to Figure 2). Appreciable rainfall, which is common in the temperate rainforest climate in which Valdez is situated, necessitated the further installation of a rain flap consisting of a strip of non-conductive geomembrane (XR-5) bonded to the CBA surface (see Figure 3) using hot asphalt *"in accordance with Alyeska's CIVE-50 Catalytically Blown Asphalt (CBA), Hypalon, or XR-5 Liner Repair Procedure"* (WSP 2024a). The shape was chosen to achieve a 15,000 ft<sup>2</sup> test intended to *"optimize drainage and minimize other conflicts"* (WSP 2024a). The shape that was selected added complexity to trenching and the installation of the rain flap.

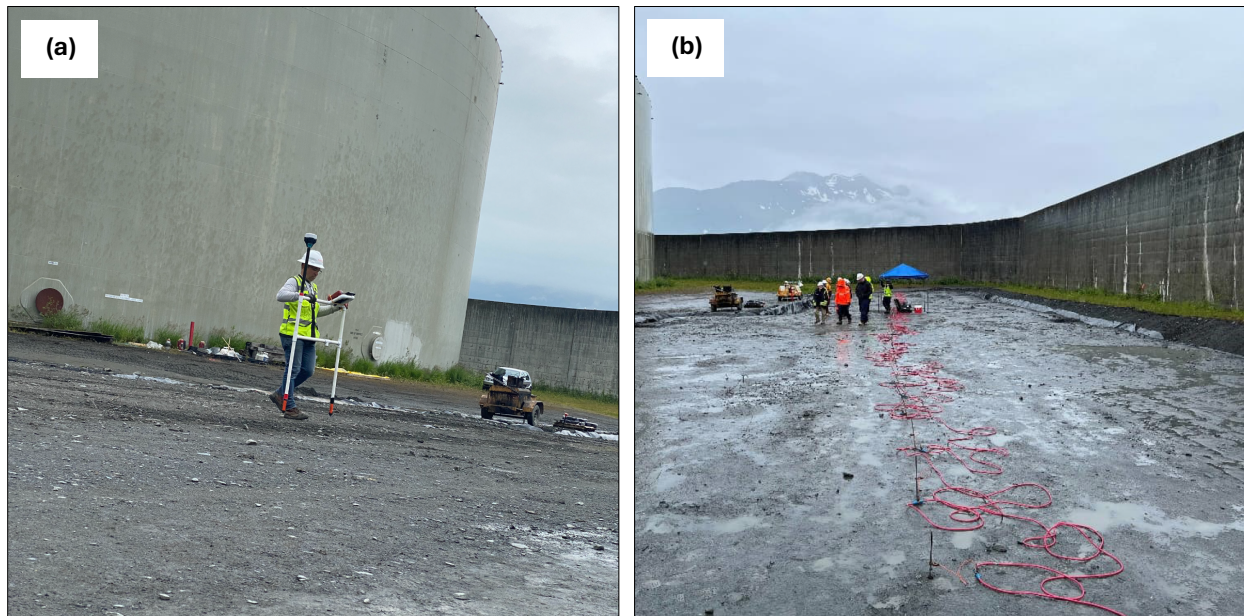
**Figure 4. Photographs (a) electrical leak location survey and (b) electrical resistivity tomography (from WSP 2024a)**

ELL surveying (shown in Figure 4a) was performed in general accordance with ASTM D7007-24, *Standard Practices for Electrical Locating Leaks in Geomembranes Covered with Water or Earthen Materials* (ASTM 2024) and ASTM D8265-23, *Standard Practices for Electrical Methods for Mapping Leaks in Installed Geomembranes* (ASTM 2023). These methods are appropriate for ELL testing and are widely used in practice. Equipment used for ELL surveys is described in WSP (2024a) and is typical and appropriate for the work conducted. Initial testing demonstrated the gravel cover over the CBA was electrically isolated via the isolation trench. The ELL survey was initially conducted using east-west transects, but both north-south and east-west transects were used to evaluate manufactured leaks.

ERT (shown in Figure 4b) was performed along three approximately parallel transects running north-south in general accordance with ASTM D6431-18, *Standard Guide for Using Direct Current Resistivity Method for Subsurface Investigation* (ASTM 2018). Equipment used for ERT surveys is described in WSP (2024a) and is appropriate for the work conducted. Data were processed and the interpretation was conducted using industry standard commercial software.

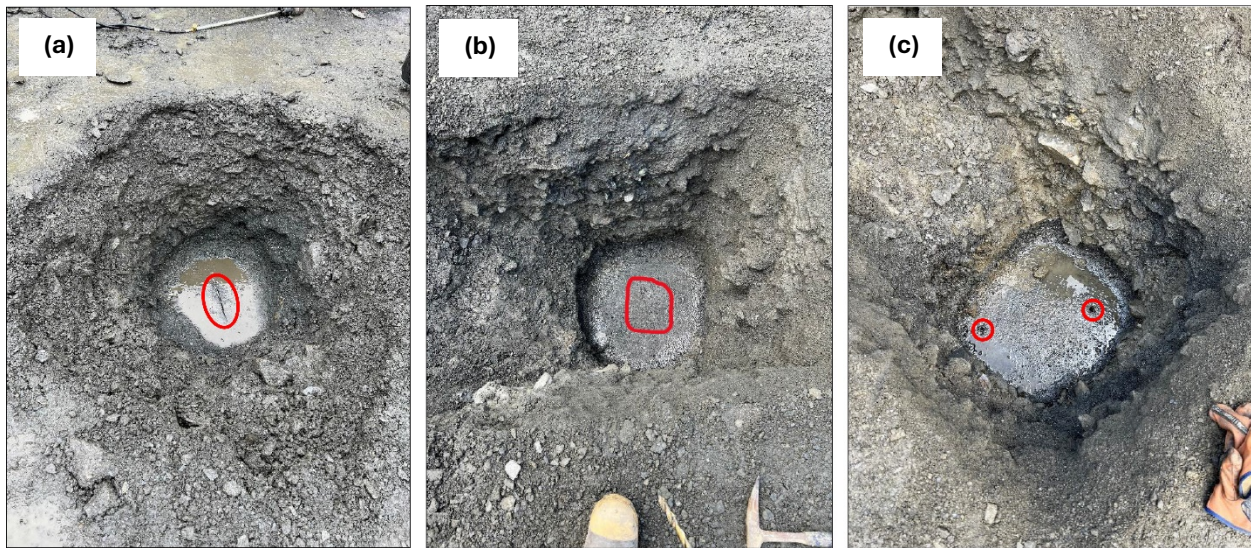
**Figure 5. Photographs of manufactured defects: (a) a rip/cut 12-inch long with a ½-inch gap, (b) a rip/cut 6-in long without a gap, (c) a 1-in-diameter hole and a ½-inch-diameter hole (photos from WSP 2024a). Red oval in (a) outlines the rip/cut. Red outline in (b) outlines the rip/cut. Red circles in (c) outline the holes.**

After initial ELL and ERT surveys, four fully penetrating rips/cuts or holes were intentionally made (manufactured) in the CBA liner and re-buried. These defects are shown in Figure 5 and consisted of (1) a rip/cut 12-inch long with a ½-inch gap, (2) a rip/cut 6-in long without a gap, (3) a 1-in-diameter hole, and (4) a ½-inch-diameter hole.

1. ***ELL can effectively locate larger leaks in the CBA.*** *East-west ELL survey transects did not detect any potential leaks but also did not detect any of the manufactured leaks. North-south ELL survey transects were effective at locating the larger manufactured leaks. Therefore, future ELL survey transects should be run both parallel and perpendicular to one another (e.g., both north-south and east-west).*

WSP notes that north-south survey transects were effective at locating the larger manufactured leaks, whereas none of the manufactured leaks were identified along the east-west survey transects. This dependence of transect orientation (north-south vs. east-west) is not common and is likely due to subsurface features that exist in the West Tank Farm, such as metal pipes, storm drains, and structural elements associated with the tank farm. These features may act as preferential flow paths for current below the liner, affecting orientation of the applied electrical field and masking electrical anomalies from defects in the CBA. Similar subsurface features are likely to exist in the East Tank Farm.
