Update on Review of Secondary Containment Liner Testing

Presented by Sadie Blancaflor and Dr. Joe Scalia (subcontractor to Dr. Craig Benson)

Presented to Prince Williams Sound Regional Citizens' Advisory Council

Board of Directors Meeting September 19-20, 2024

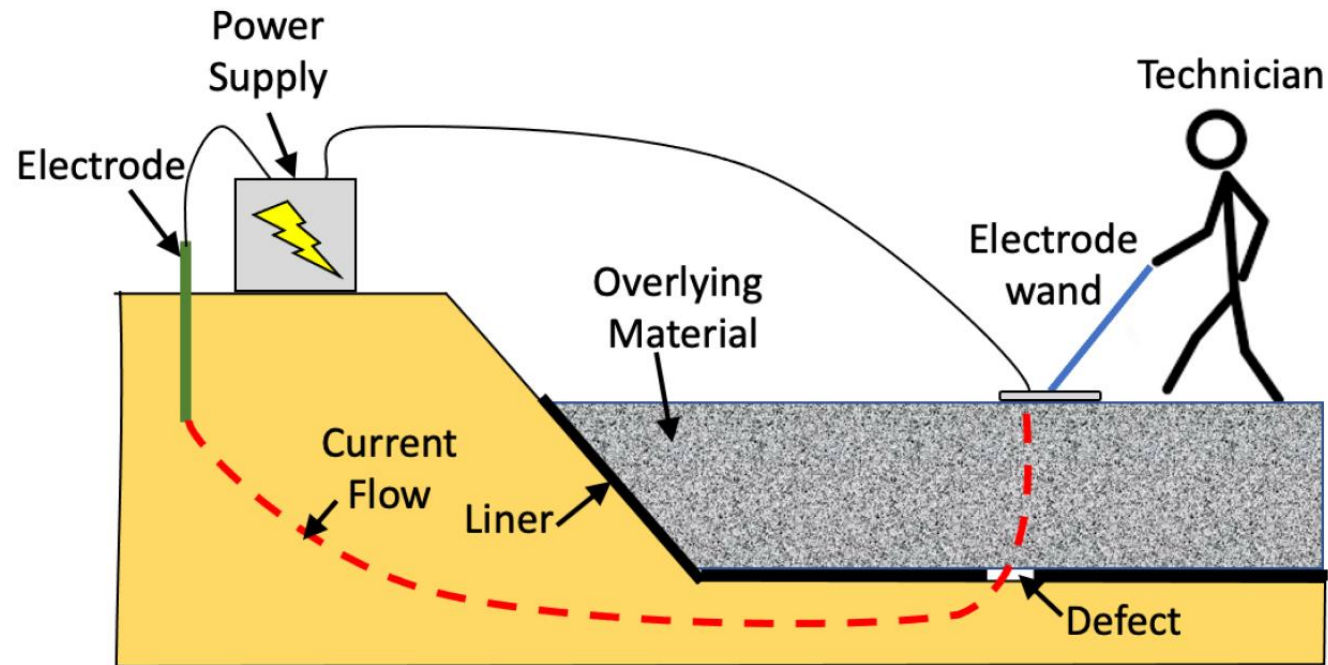
Electrical Leak Location (ELL)

Following ASTM D7007 Standard Practices for Electrical Methods for Locating Leaks in Geomembranes Covered with Water or Earthen Materials

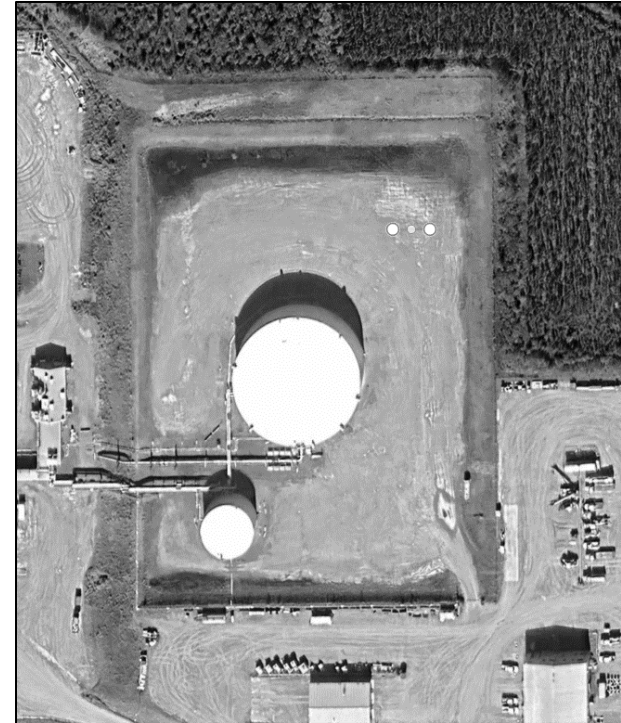
Example ELL results for 15×15-m region of TAPS Pump Station 5 SCS

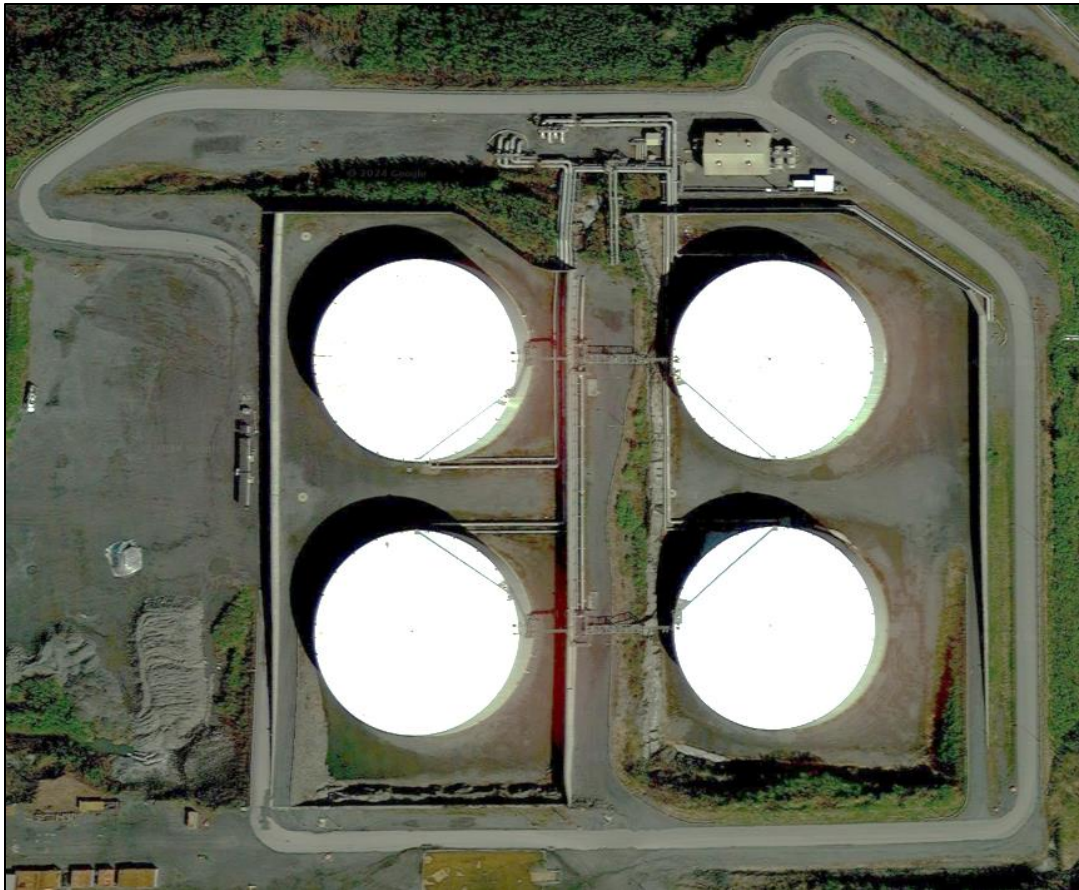
VMT WTF; note lack of pre-existing electrical isolation

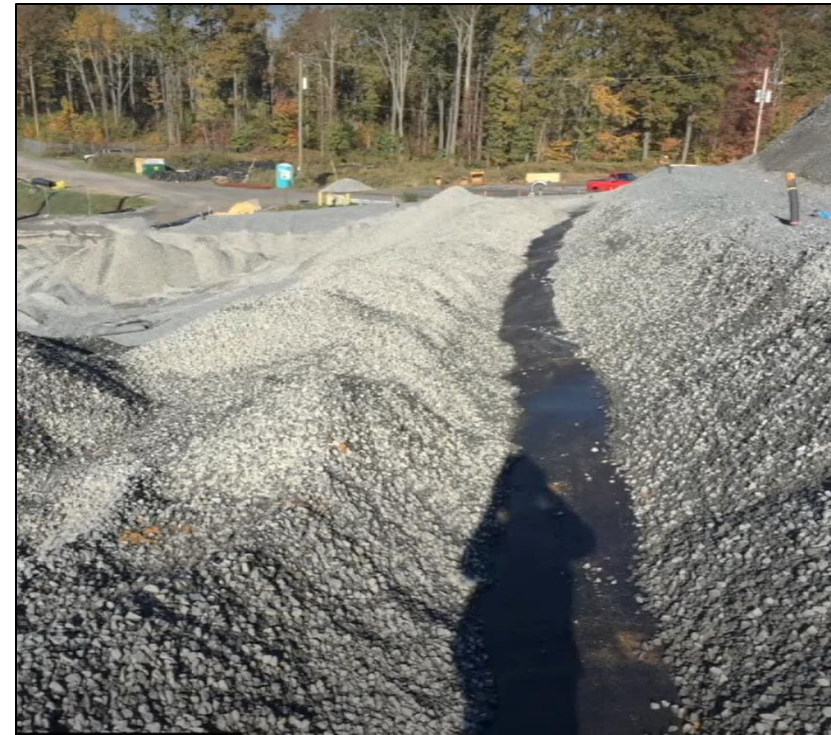
Example of ELL isolation trench
(not at VMT)

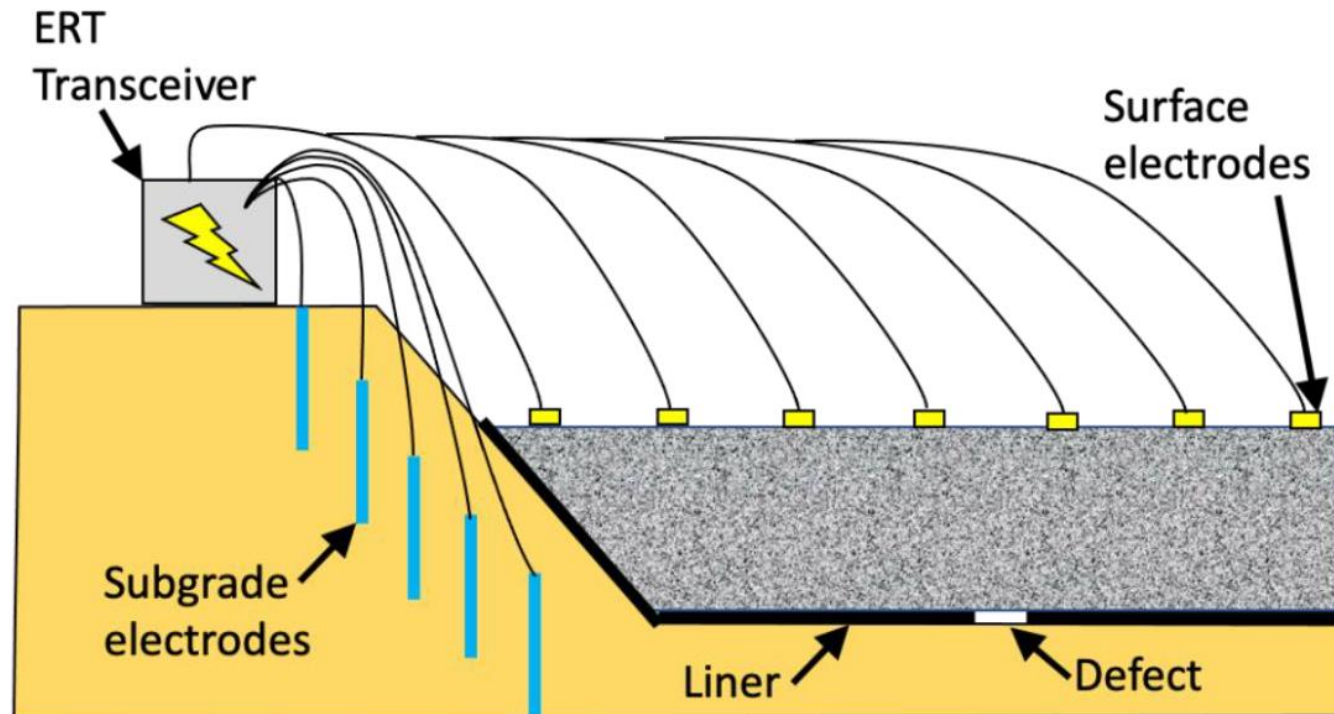
Electrical Resistivity Tomography (ERT)

- More elaborate version of ELL
- Generates 3D map of subsurface current flow

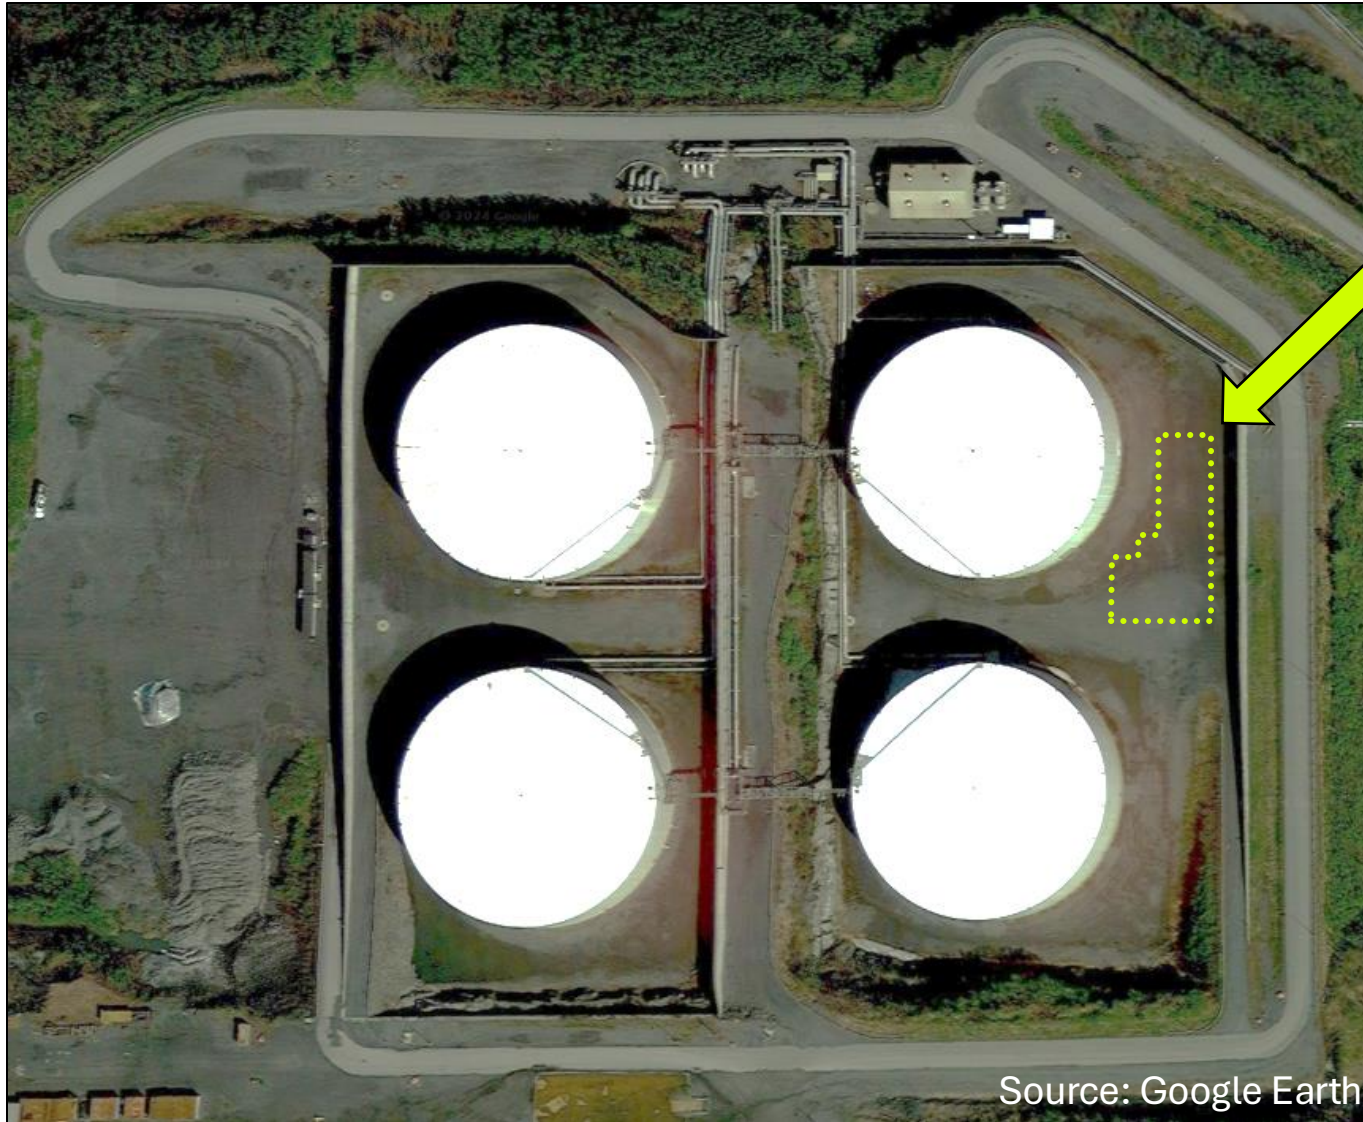
Approximate pilot test location
($\approx 15,000$ sf)

- Testing performed by Alyeska's contractor (WSP) July 22-29, 2024
- Testing consisted of:
 - Establishment and verification of electrical isolation
 - ELL testing
 - ERT testing
 - Investigation of identified (minor) anomaly identified by ELL
 - Installed and buried three defects (large gash, small gash, knife slit)
 - ELL testing
 - SCS repair
- As of now, photos and a report providing the results of testing have not been received

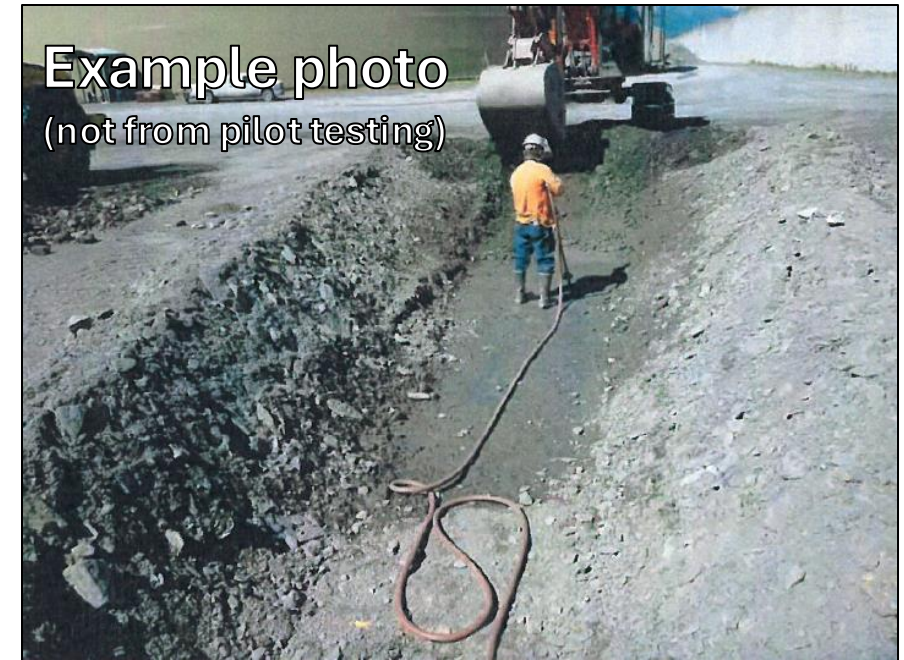
Example photo
(not from pilot testing)
