Crude Oil Tank Pressure-Vacuum Vent Damage

Bill Mott (Taku Engineering)

Prince William Sound Regional Citizens' Advisory Council

January 2025

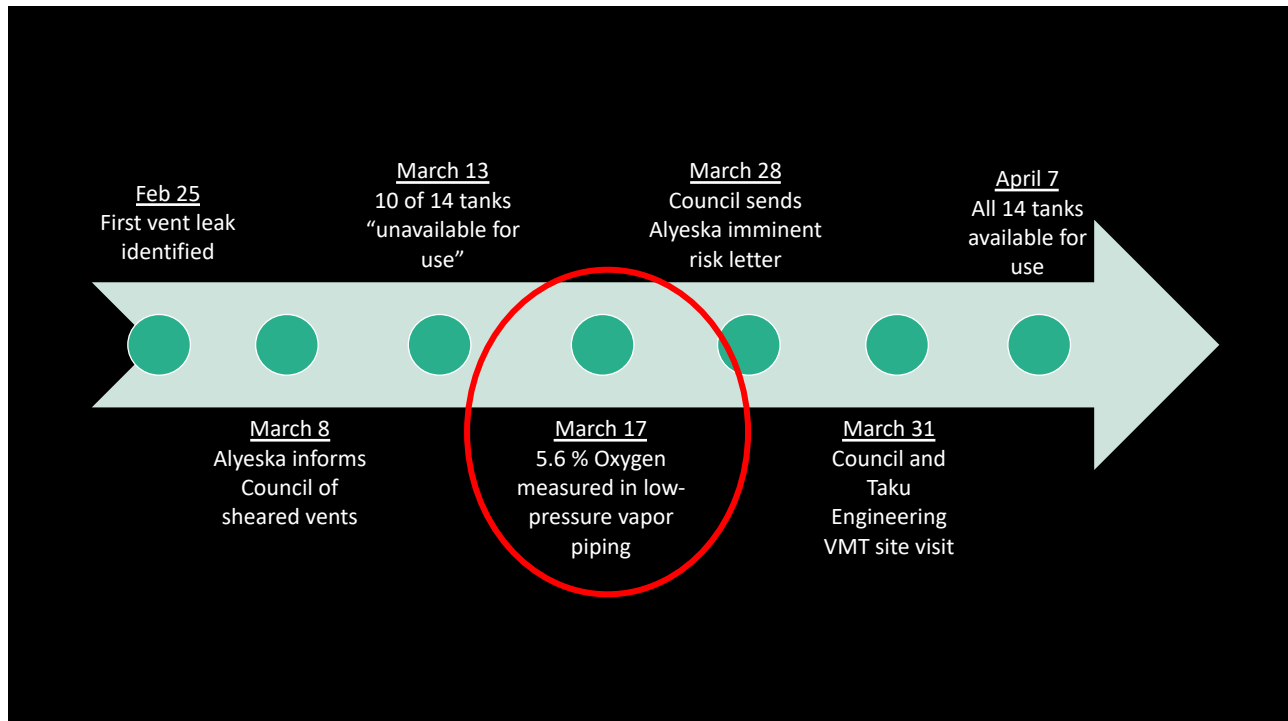
- The leaks were initially discovered through an “Olfactory Test”
 - The technician smelled hydrocarbons.
- The O₂ concentration monitoring in the Low-Pressure Vapor Header is limited to two points in the low-pressure header, one on the ETF header and one from BWT.
- Thief hatches were used to monitor the O₂ content of the tank headspaces to determine if it was safe for workers to access the tank tops for snow clearing.

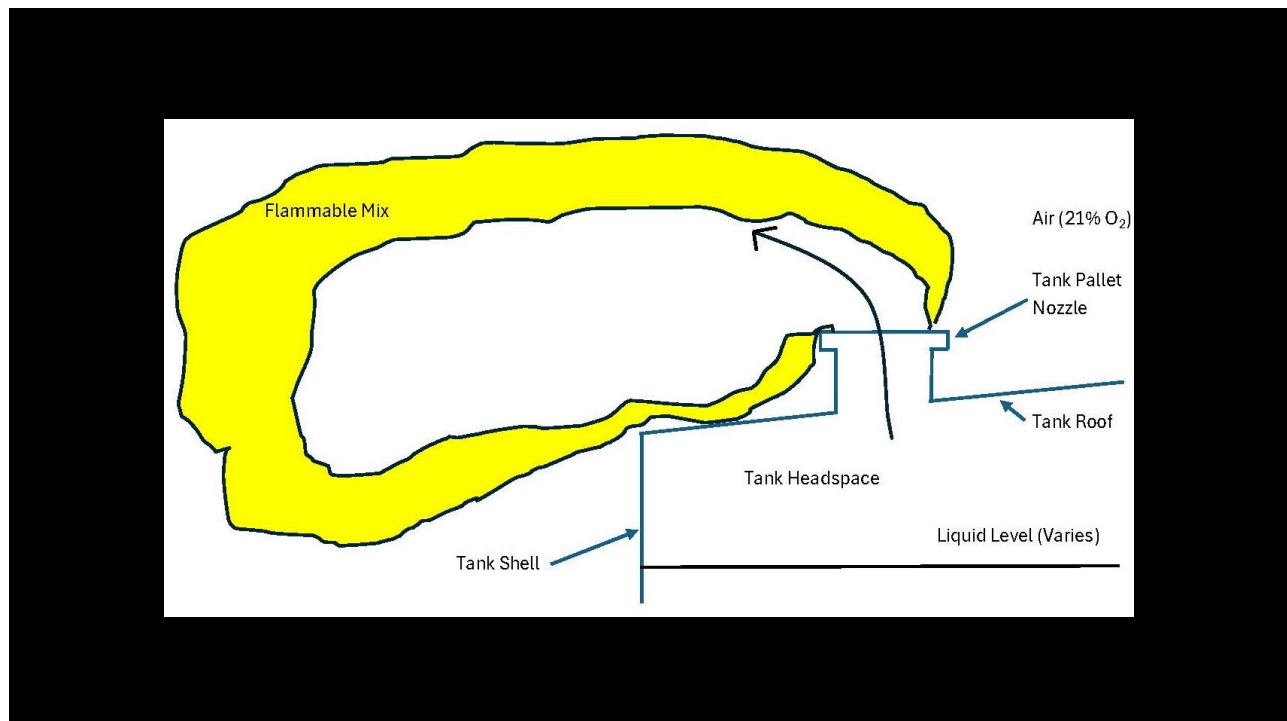
The use of the “Olfactory Test” as the primary means to detect leaks in the vapor system within the East Tank Farm.

- The sense of smell varies from individual-to-individual
- An individual may be subjected to a potentially hazardous environment in order to practice the olfactory test in the event of an upset

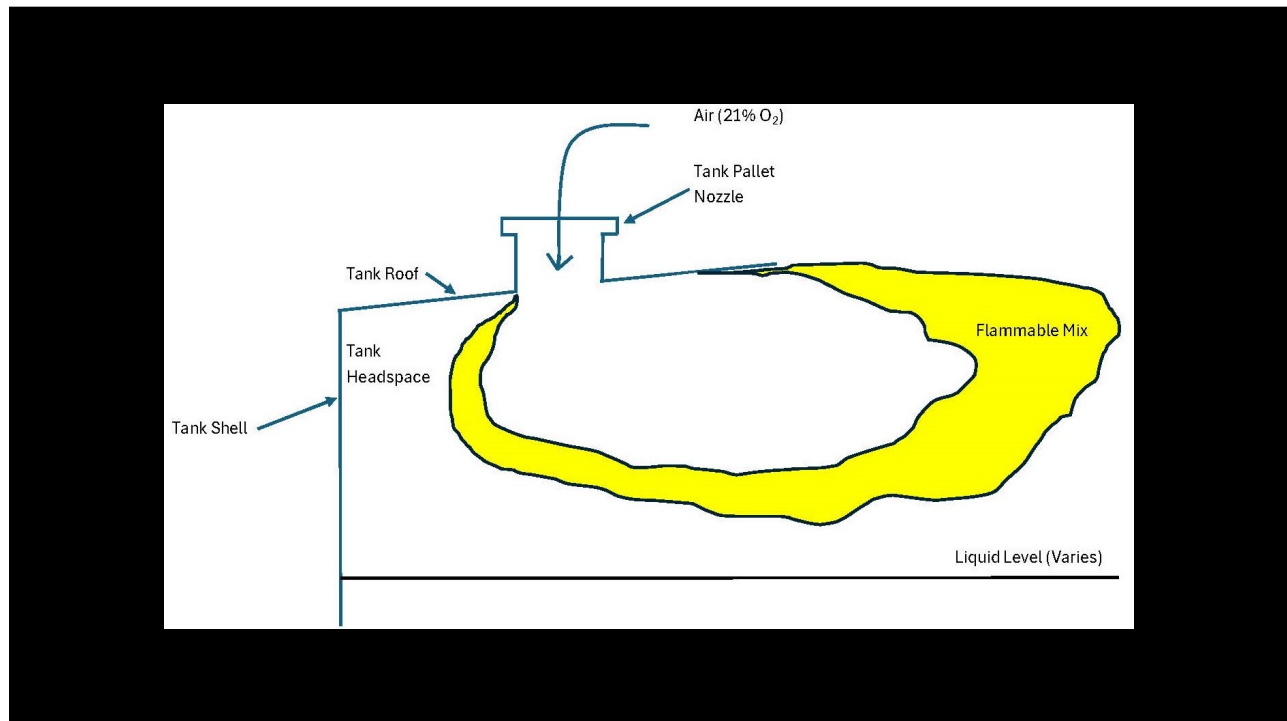
Alyeska's measures to operate at a negative vacuum resulted in O₂ intake into the tank headspace, creating localized areas of the tank headspace containing a flammable gas mixture, which in the presence of an ignition source could have resulted in an accident.

- The crude tanks are normally operated at a slight positive pressure. The mode was shifted to a slight vacuum (negative pressure) once vapor leaks were discovered in a tank.
- In my professional opinion, once the tank operating mode was shifted to a slight vacuum in the headspace, localized areas of the headspace near the significantly damaged pallets contained a flammable gas mixture.
